Pentium® Processor Specification Update

Release Date: March, 1995

Order Number: 242480-002

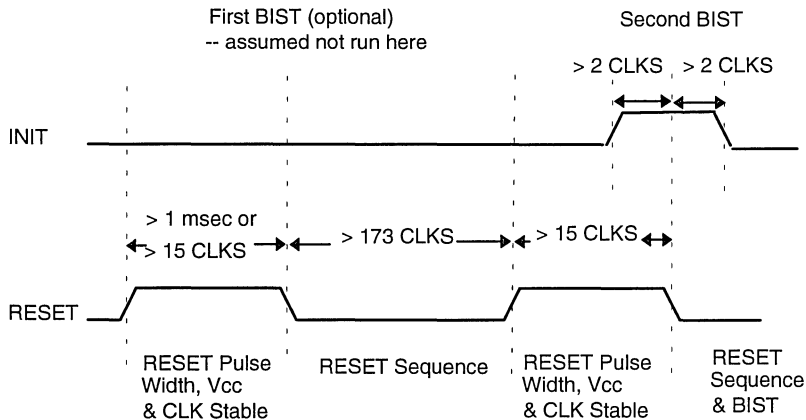
21. Power-Up BIST Failure

1. Invoke a double RESET — All false BIST failures have occurred during cold RESET. In order to accurately execute BIST, a double RESET sequence may be performed as shown in the figure below:

The first RESET pulse is used to ensure that all logic used in the BIST test is correctly initialized; optionally, INIT may be driven high to enter BIST at the falling edge of the first RESET. In this case the results of the first BIST should be ignored.

After de-assertion of the first RESET pulse, a minimum of 173 clocks must elapse before assertion of the second RESET. (Note that if BIST was entered at the end of the first RESET, this 173-clock requirement is satisfied by the time required to complete the first BIST.) During the second RESET, INIT is toggled high in order to run the 'real' BIST. This BIST correctly returns results in EAX.

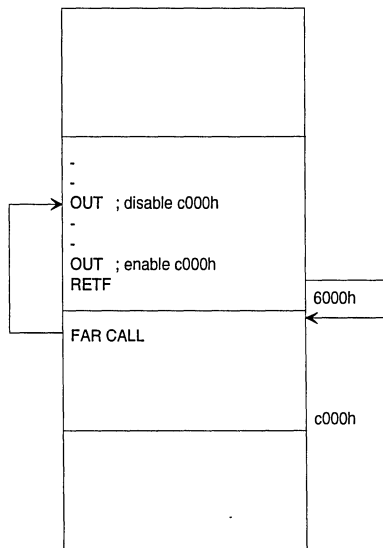
1. Code passes control to segment at address c000h.
2. Transfers control to code at different address (6000h) by using FAR CALL instruction.
3. This portion of the code does an I/O write to a port that disables memory at address c000h.
4. At the end of this segment, an I/O write is performed to re-enable memory at address c000h.
5. Following the OUT instruction, there is a RETF instruction to c000h segment.

The branch prediction mechanism of the Pentium processor, however, predicts that the RETF instruction is going to transfer control to the segment at address c000h and performs a prefetch from that address prior to the OUT instruction that re-enables that memory address. The result is that no BRDY is returned for that prefetch cycle and the system hangs.

In this case, branch prediction should be disabled (by setting TR12.NBP and flushing the BTB by loading CR3) prior to disabling memory at address c000h and re-enabled after the RETF instruction by clearing TR12.NBP as indicated above.

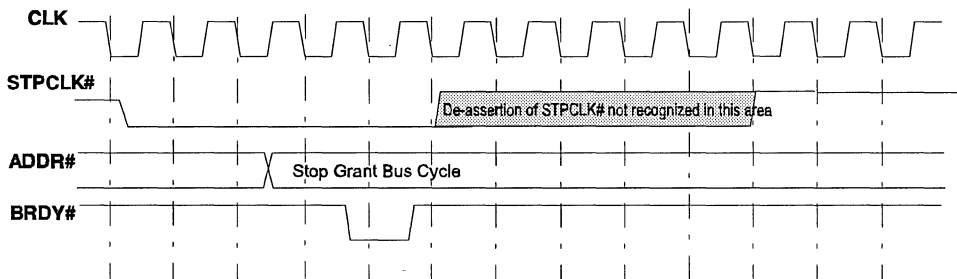
PROBLEM: A de-assertion of STPCLK $\#$ might not be recognized during a 5 CLK period while the processor is in the Stop Grant state. This situation is described more clearly below.

When STPCLK $\#$ is asserted, the processor indicates recognition of the STPCLK $\#$ interrupt by driving a Stop Grant special cycle on the bus. Once the BRDY $\#$ is returned for this special cycle, the processor enters the Stop Grant State (low power state). If STPCLK $\#$ is de-asserted (driven high) too soon (within 5 CLKs) after the BRDY $\#$ is returned, the processor will not recognize the deassertion of STPCLK $\#$ and may not return to the Normal state to begin instruction execution. In other words, there is a 5 CLK window after BRDY $\#$ where a STPCLK $\#$ de-assertion might not be recognized (causing the processor to remain in the Stop Grant state rather than returning to the normal state).

IMPLICATION: Some systems use STPCLK $\#$ deassertion to execute single instructions, to guarantee the execution of a single instruction by throttling STPCLK $\#$ in this manner, the STPCLK $\#$ must meet the 5 clock minimum deassertion time after the BRDY $\#$, otherwise the processor may not return to the normal state to continue instruction execution.

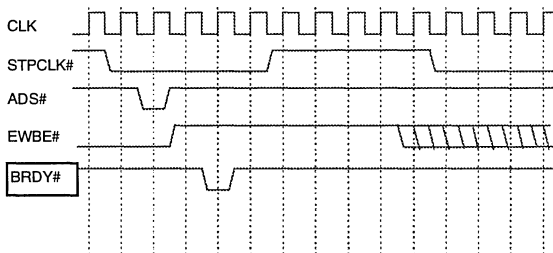
1. The STPCLK# pin is asserted.
2. The Stop Clock special cycle is started on the bus.
3. The EWBE# pin is de-asserted prior to the return of the BRDY# for the special cycle.
4. The BRDY# is returned from the bus.
5. The STPCLK# pin is de-asserted and then re-asserted prior to the assertion of the EWBE# pin.
6. Upon assertion of the EWBE# pin, the CPU will stop its internal clocks without running a Stop Clock special cycle.

IMPLICATION: This erratum affects only those systems that use both STPCLK# and EWBE#. If the system gates the de-assertion of STPCLK# with the return of the Stop Clock special cycle, then there is a possibility if EWBE# is used in a manner that meets these conditions that the system may lockup.

WORKAROUND: Make sure that the re-assertion of the STPCLK# pin happens 3 or more clocks after the assertion of the EWBE# pin.

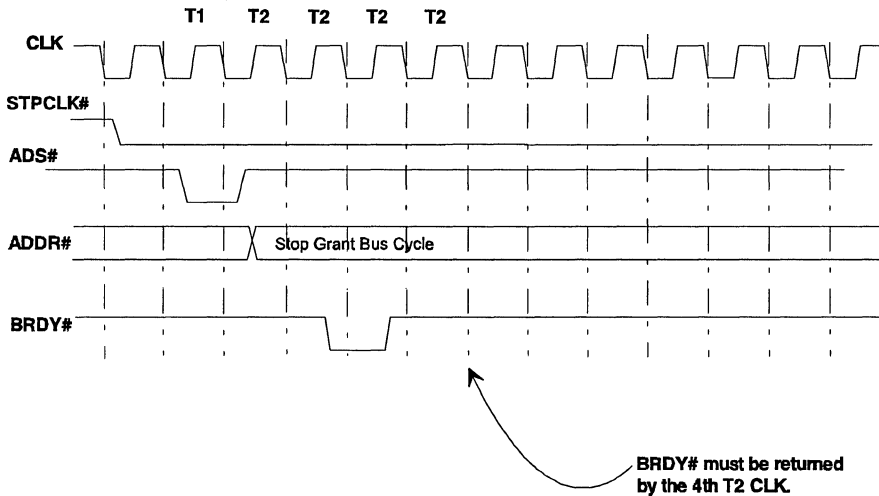
IMPLICATION: This problem occurs only in dual processor systems and will cause one of the processors to hang.

WORKAROUND:

1. Do not assert STPCLK#.
2. Ensure that BRDY# is asserted within 4 CLKs after the Stop Grant bus cycle has begun.

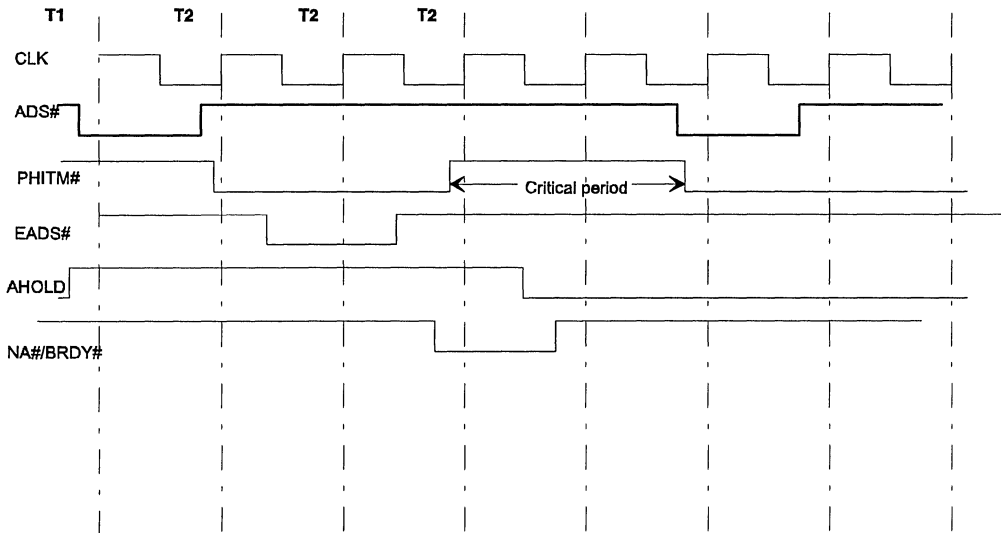
6. After the memory-write cycle is complete, the LRM performs its write-back.
7. The MRM then re-issues the memory write-cycle again. This cycle, now being issued for the third time, causes an internal hangup in the MRM.

IMPLICATION: If a memory write or memory read cycle is pending on the bus and an external snoop occurs, one of the processors may hang.

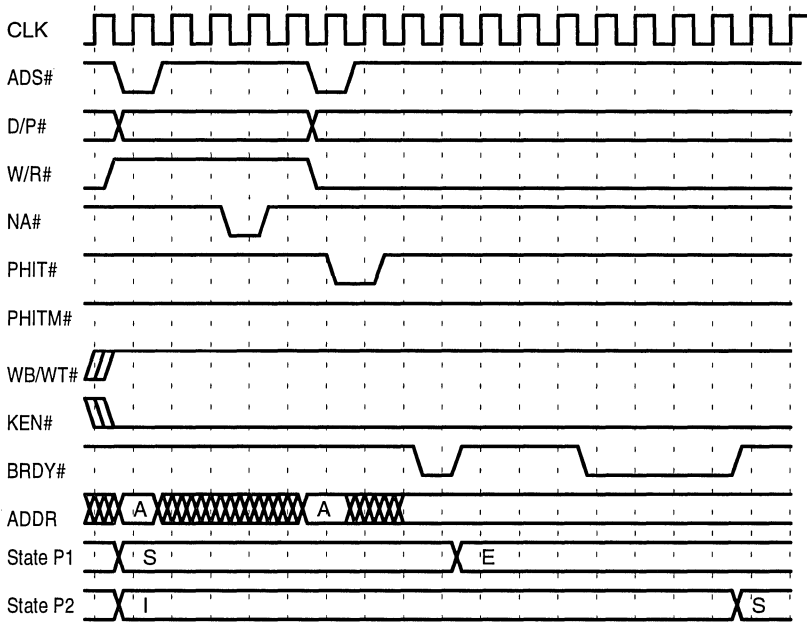
PROBLEM: This is a dual processor errata: If there is a READ generated by processor 2 pipelined into a WRITE generated by processor 1, and both of these cycles are to the identical address, the cache states for these lines become inconsistent. In this case the WB/WT# pin is driven HIGH, and the KEN# pin is active. Processor 1 will have data that changes from the (S) shared state to the (E) exclusive state, and processor 2 will have data that changes from the (I) invalid state to the (S) shared state. This violates the cache coherency protocol, since any writes to the line that is in the (E) state in processor 1 will not be seen on the bus, resulting in the second processor operating with stale data. This is a symmetrical problem, such that the initiator of the WRITE cycle can either be the primary or dual processor in a two processor configuration. The reason this happens is that each ADS# causes a snoop in the LRM processor, but in this case at the time of the snoop the line state is (S) which will generate the PHIT#, and no PHITM#, the transition to the (E) state has been posted but is not performed until the BRDY# of the WRITE cycle.

IMPLICATION: If the described conditions are met, then an additional write to the same address in processor 1 will cause a cache state transition from (E) to (M) and will not generate a bus cycle. This will mean that the data in processor 2 is stale but it could continue operating with the stale data. For example: when 2 processors are sharing a cached semaphore, and processor 1 is updating the semaphore just as processor 2 is reading the semaphore, then processor 2 would eventually end up with stale data in its cache. Due to the nature of the problem, this could cause a number of unknown system problems and may or may not cause a system to hang.

WORKAROUND: Disable pipelining while using dual processing, this is done by not asserting NA#.

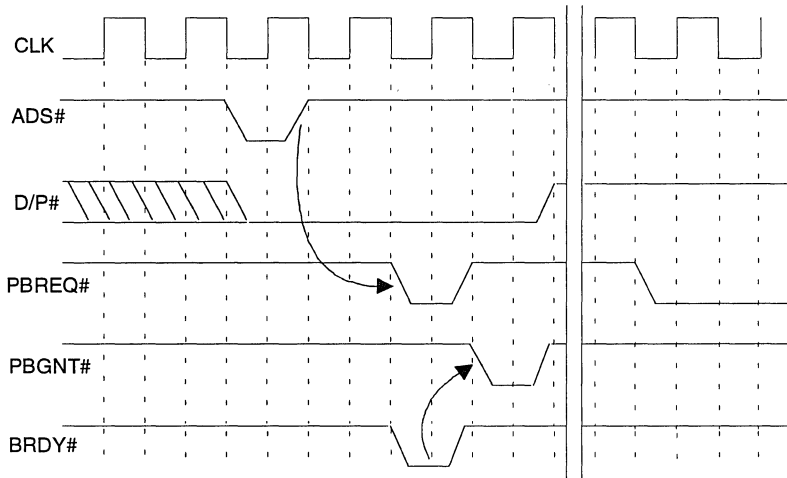
7. CPU A asserts PBREQ# to CPU B in order to obtain bus ownership back to run its pending cycle.
8. CPU B, however does not grant the bus back to CPU A since it needs to run a bus cycle before relinquishing the bus ownership. Since interrupts are disabled and the processor is executing in a tight 'spin' loop, it does not have any bus cycles to run and does not relinquish the bus.

IMPLICATION: A system lockup can occur because one CPU requests the bus, while the other CPU does not relinquish bus control. Running Windows NT operating system, it has been observed that when the hang condition occurs, the code inside the Windows NT kernel is always inside a very tight code loop, with at least one of the processors 'spinning' on a semaphore location, with interrupts disabled, waiting for the other CPU to complete its task.

WORKAROUND: Asserting STPCLK# to the processor that owns the bus will cause the system to come out of the lock up condition. Using a timer, when the PBREQ# signal is seen asserted for a few thousand clocks

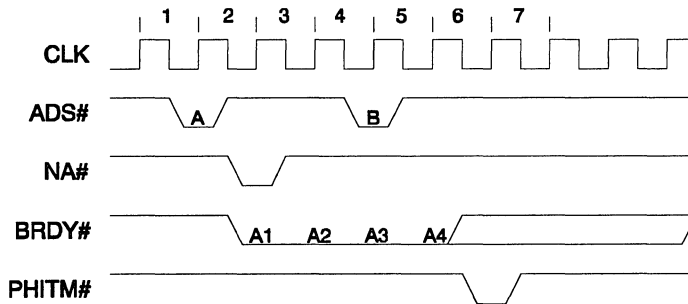
CASE 1:

- The processor issues read cycle A which may be pipelined into an earlier (unshown) cycle.
- Cycle A will be completed by the system as a 2-1-1-1 (zero wait state) cycle.
- One clock after issuance of the ADS#, NA# is asserted by the system.
- A pipelined cycle (B) is asserted by the MRM in clock 4.
- Cycle A completes on the bus in clock 5.
- One clock later, PHITM# is issued by the LRM.

Specifically given the above conditions, the error condition occurs internally in the CPU due to the assertion of PHITM# or BOFF# one clock after the final BRDY# of cycle A. If this occurs, the CPU will respond to the PHITM# or BOFF# by subsequently re-issuing both cycles A and B, where expected operation would be that only cycle B is re-issued.

IMPLICATION: The codefetch or data read cycle (A) will be re-issued even though it is already completed. The second occurrence of the cycle, even if harmless from a system point of view, will confuse the internal state of the CPU and may cause subsequent CPU mis-operation.

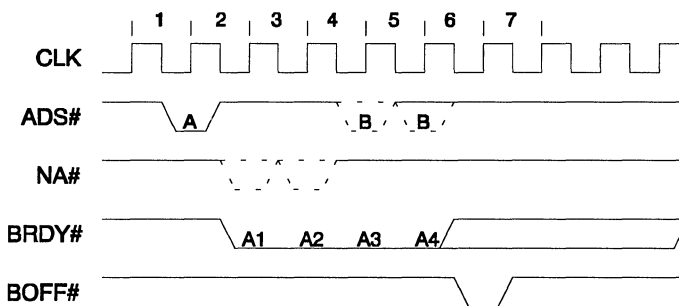
CASE 2:

- The processor issues read cycle A which may be pipelined into an earlier (unshown) cycle.
- Cycle A will be completed by the system as a 2-1-1-1 (zero wait state) cycle.
- One or two clocks after issuance of the ADS#, NA# is asserted by the system.
- A pipelined cycle (B) is asserted by the MRM in either clock 4 or clock 5.
- Cycle A completes on the bus in clock 5.
- One clock later, BOFF# is issued by the system.

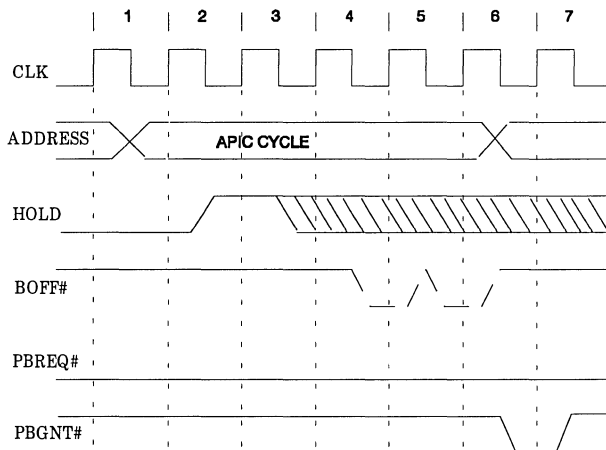
1. One of the CPUs initiates an internal APIC cycle (read or write). The LRM CPU requests ownership of the bus by asserting PBREQ#
2. HOLD is asserted during the APIC cycle
3. BOFF# is asserted before the APIC cycle gets completed, two or three clocks after HOLD is asserted (as shown in figure below)
4. Once BOFF# is deasserted, both processors may assume ownership of the bus at the same time resulting in possible contention of the CPU pins.

IMPLICATION: This problem affects DP (with CPU local APIC enabled) that assert HOLD and BOFF#. When the problem occurs, the DP arbitration machines of both processors get out of synchronization causing both processors to park on the bus. This will result in a system hang.

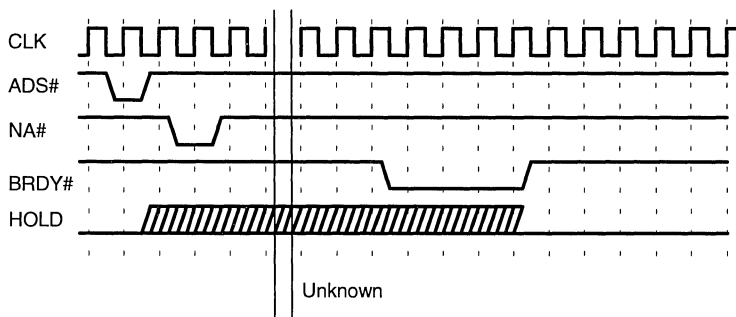
PROBLEM: This is an APIC related dual processor errata: When an APIC read cycle is interprocessor pipelined into any other allowable cycle, and HOLD is prior to the last BRDY# of the outstanding cycle, the MRM processor will hang.

IMPLICATION: A system that uses Dual processor with pipelining enabled, is subject to periodic lockups if HOLD/HLDA# protocol is used.

WORKAROUND: Use one of the following:

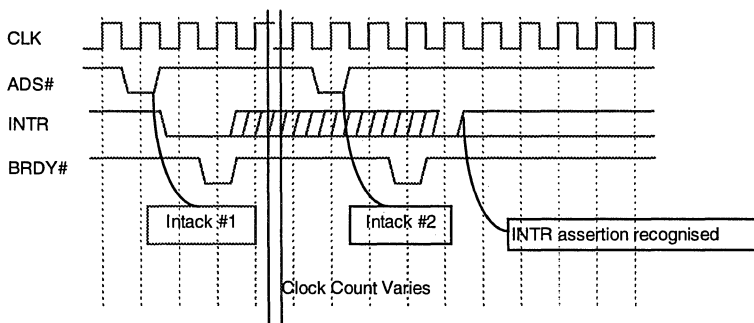
PROBLEM: This erratum affects APIC in through Local (virtual wire) mode. If a uniprocessing or dual processing system is using a 75-, 90- or 100-MHz Pentium processor with the APIC in through Local (virtual wire) mode, and the chipset is able to re-assert the INTR line prior to completion of the second Interrupt acknowledge cycle (from a prior assertion of the INTR line), then the processor will neither recognize nor service the second interrupt. The assertion edge of INTR has to occur after the completion of the second IntAck BRDY#, if there is a transition and this transition is held high during the restricted time period, this INTR will not be recognized. Software disabling of the APIC by clearing bit 8 of the SVR (spurious vector interrupt register) will not prevent this from occurring.

IMPLICATION: If the conditions listed above are met the system may hang up since there would be an interrupt that would not get serviced.

WORKAROUND: Use one of the following:
