Repair: Apple Macintosh PowerBook 100 “Gotta re-cap ’em all!”

Posted on [September 24, 2016](#) by [lui_gough](#)

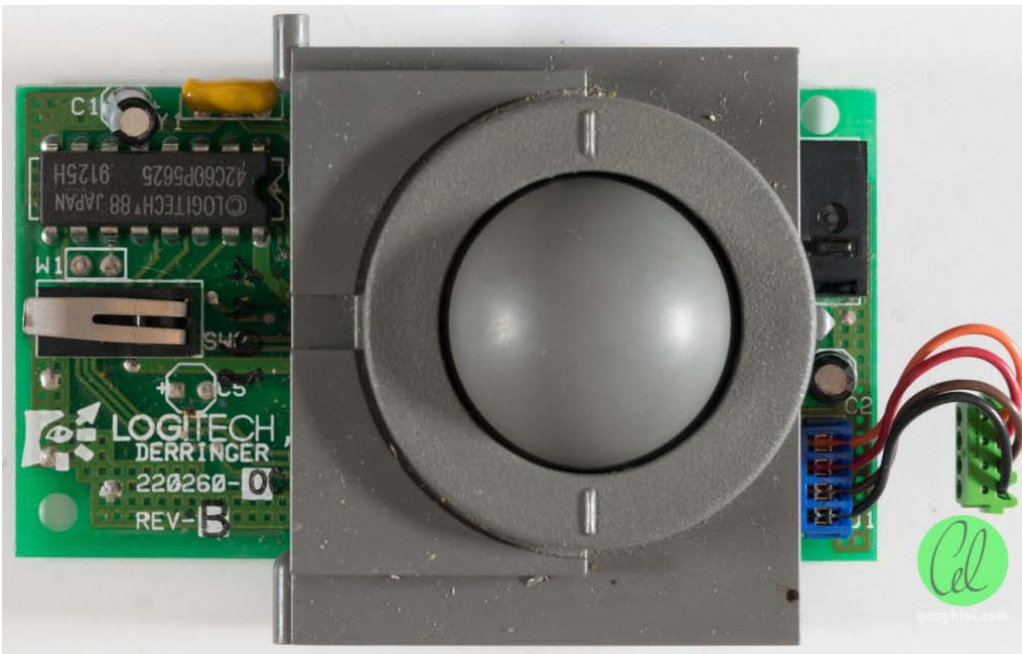
One of the biggest surprises to me was that the trackball was a **Logitech** product. I didn't expect that. **Because I wasn't paying attention, I didn't even notice C1 or C2** and so I forgot to order replacement capacitors for this entirely. Whoops. I noted down the value of C1 (0.22uF/50V), but not C2 ... sometimes these things are a little tricky.

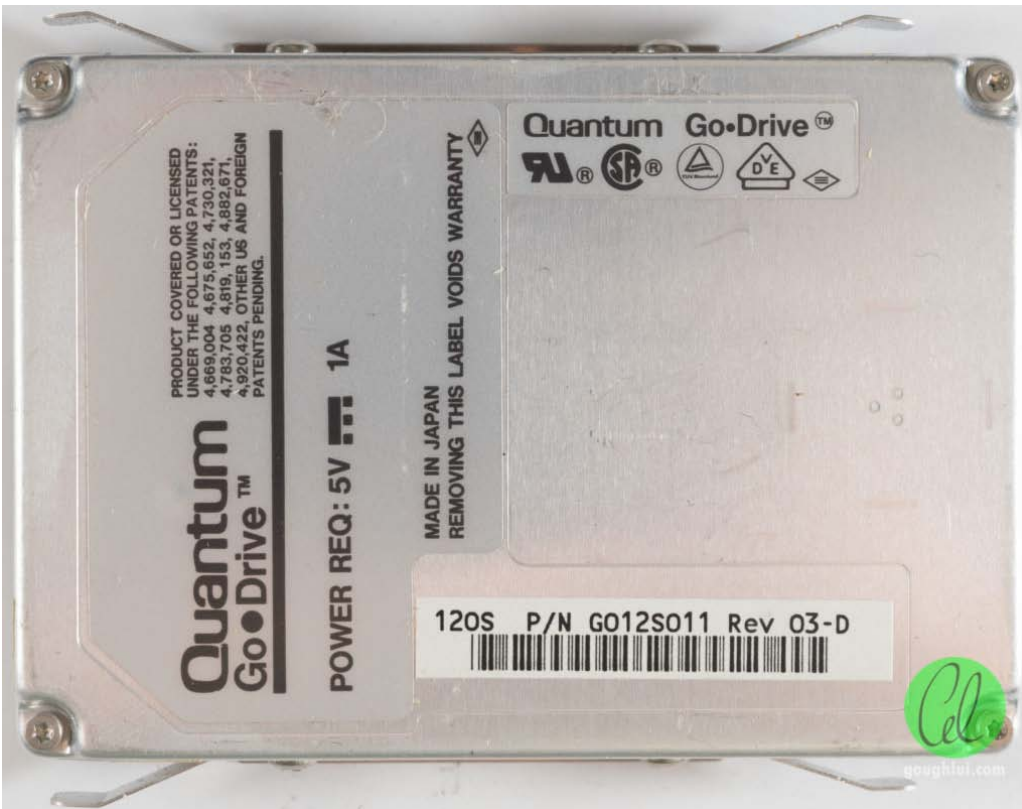
Sadly, these are known to be failure prone nowadays, because of their internal rubber parts which have also probably disintegrated into goo.

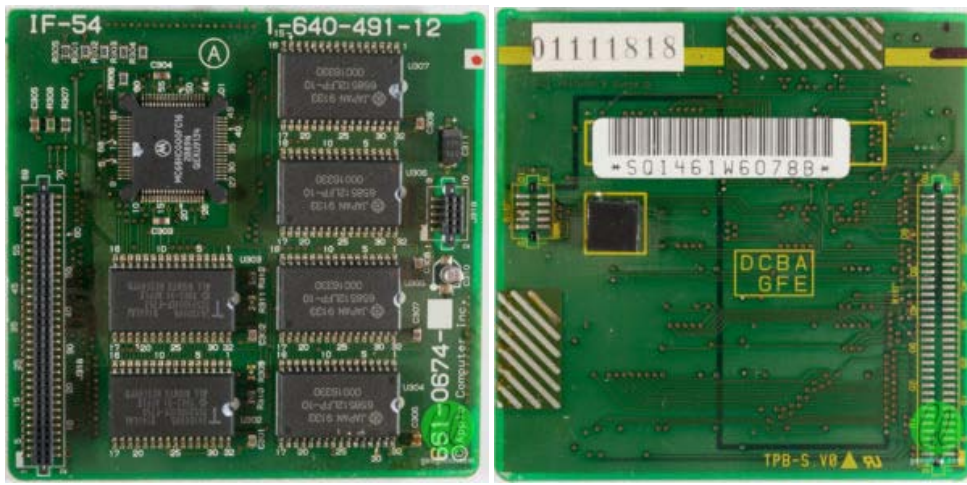
This would turn out to be our first patient, as this has an SMD electrolytic capacitor near the small connector. The tantalum next to it doesn't necessarily need replacement.

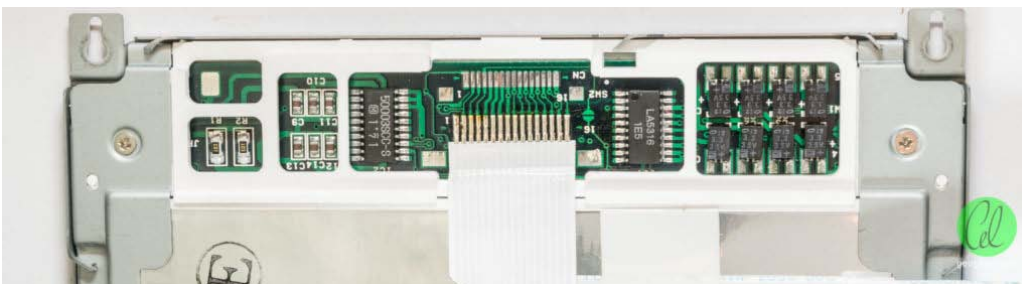
The units had frosty joints, a sure sign of bad capacitors. To get to it involved undoing four screws, bending out the retainer tabs, taking out the side metal strips, then removing the backlight assembly entirely, exposing the LCD screen itself.

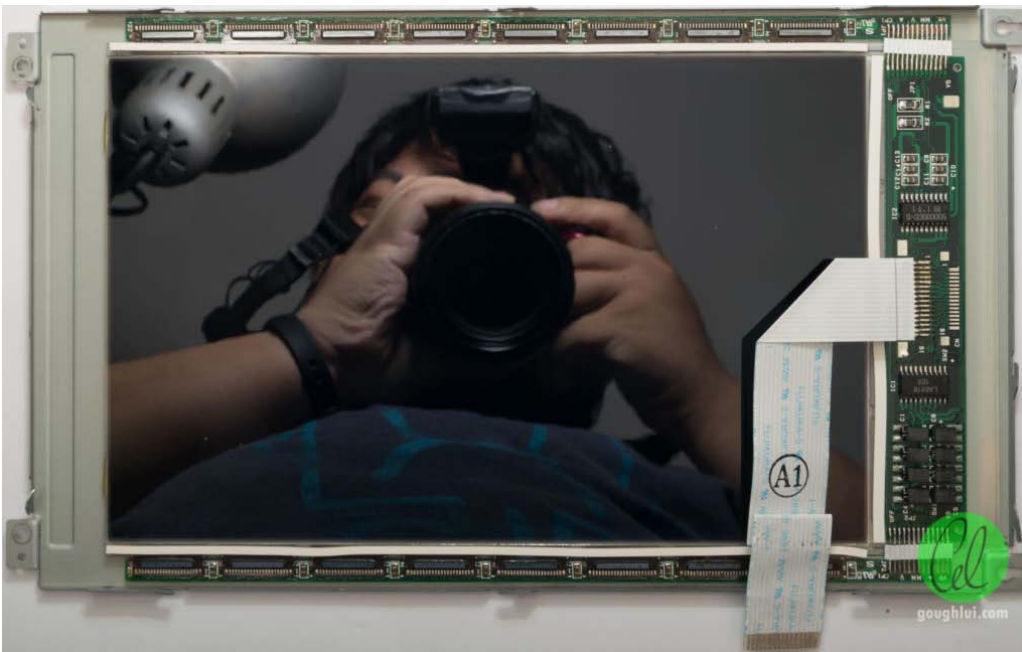
We can see the flat-panel chip-on-flex drivers top and bottom. The flexible flat cable was very carefully threaded out from the frame – it's not on a connector on the PCB side which makes it both fragile and annoying.

To work with the board and screen in such close proximity is dangerous, so it's advisable to have some paper to cover the LCD during work, so that it doesn't become the victim of solder/flux splashes and scratches when repositioning. Due to the close spacing, desoldering was a bit of a challenge. Desoldering the capacitors shows you just how bad residue can be.

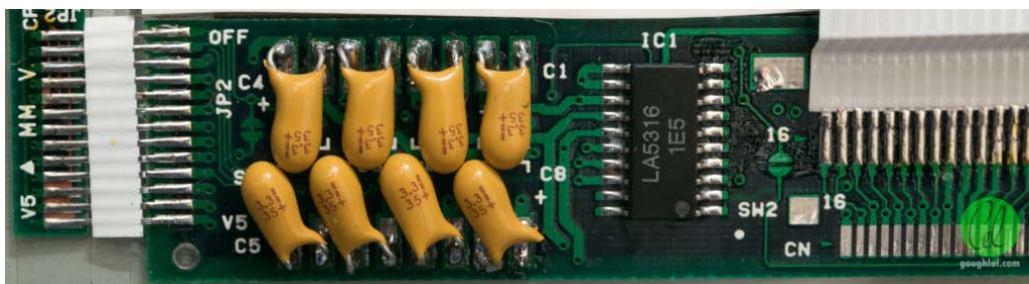
Unfortunately, when reassembling, I found a slight interference between C5 and the plastic frame, so a little bit of a snip was needed.

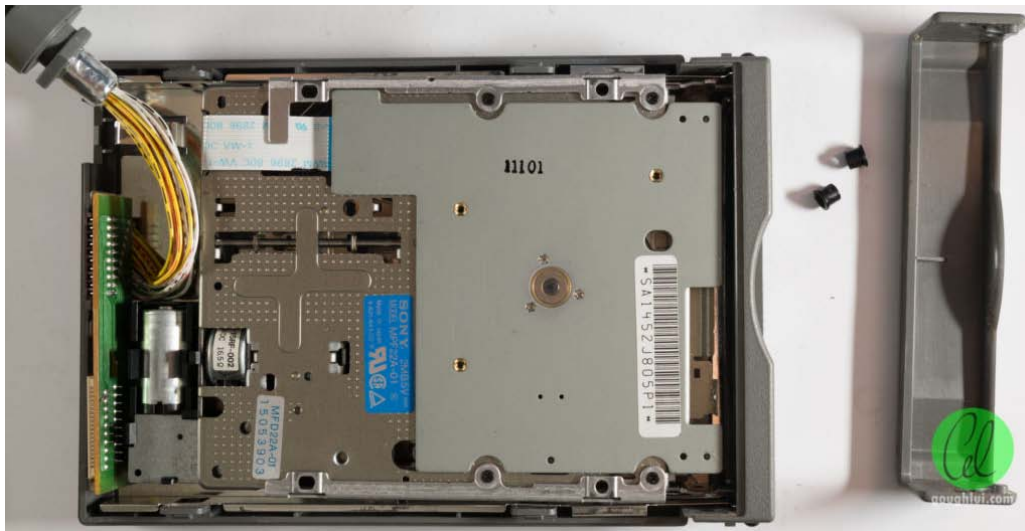
Now that all the internal bits have been attended to, it's also worth attending to the floppy drive, just in case there's something that needs to be serviced there. I didn't have any teardown instructions, but I seemed to have worked it out. If you unclip the front

swivel cover, you can remove two plastic rings which allows you to slide the two parts of the case apart. That's literally it.
