Pentium® Processor Specification Update

Release Date: March, 1995

Order Number: 242480-002

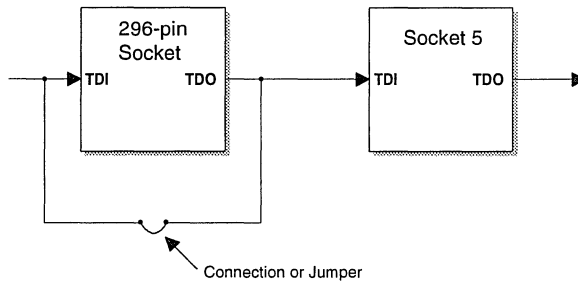
Other implications of this workaround include Boundary Scan, and any other signals not connected together between Socket 5 and the 296-pin SPGA socket site.

If Socket 5 follows the 296-pin socket in the Boundary Scan chain, the TDI input and TDO output of the 296-pin socket site must be connected together by the OEM prior to system sale in order to skip this socket site and complete the path to socket, as shown in the following figure. This connection is necessary only if Boundary Scan will be used by end-users after system sale.

All of the signals which are not connected together in a dual socket system must be handled by both socket sites if the feature is desired. These signals are APCHK#, BP[3:0], IERR#, PM[1:0], PRDY, and R/S#.

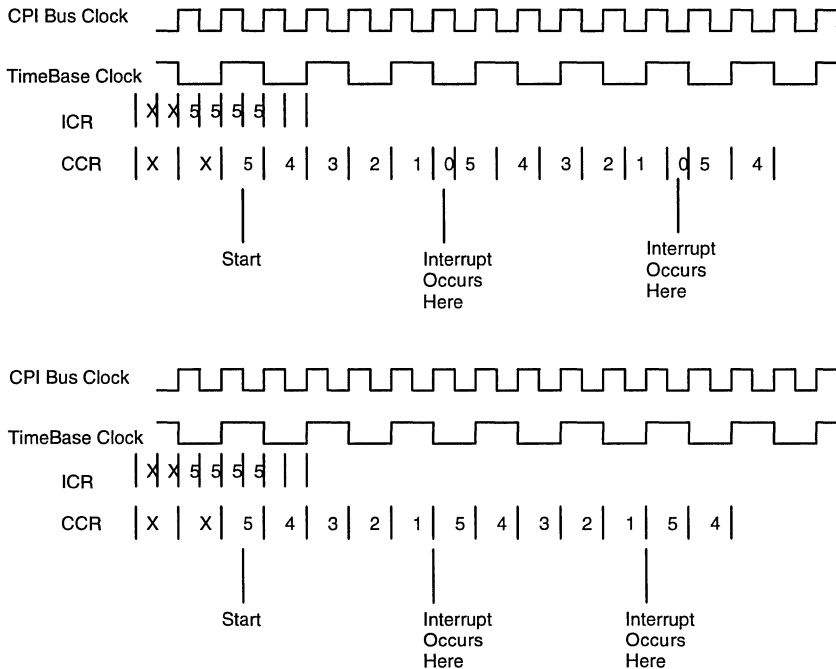
The APIC Timer functions correctly, but there is one timer "tick" that is a different pulse width than the other timer "ticks". The countdown performs correctly regardless of the divisor that is programmed, each of these ticks is of the same pulse width, but the last tick is held for just one single timer clock regardless of the divisor programmed. This results in a slightly inaccurate timer. This last tick pulse width is shown in the top diagram. The lower diagram shows how the accuracy of the timer will be corrected in a future stepping. This phenomenon occurs when the timer is used as a single shot generator as well.

Note: The CPU Bus clock in which the CCR is loaded from the ICR occurs one clock after the ICR is loaded.
